MITIGATING CORROSION UNDER INSULATION (CUI)

SPREAD OF CORROSION ASSESSMENT ON ARMAFLEX INSULATION
SYSTEMS IN A CONTINUOUS SALT-WATER SPRAY ENVIRONMENT

test conducted by
TNO/Endures

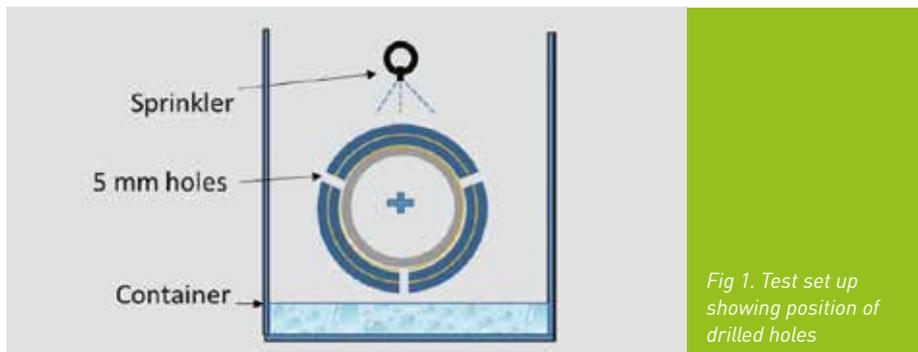
Pipe B

Pipe A

- Layer 1 – 25mm of HT/Armaflex Industrial insulation all over adhered to pipe.
- Layer 2 – 25mm HT/Armaflex Industrial insulation all over adhered to the first insulation layer.

To simulate failure modes within the insulation system, 5mm^{***} holes in 3 rows - each row with two holes (at 2, 6 and 10 o'clock positions) – were introduced to the upper and lower surfaces.

The holes were drilled through the insulation to allow water to ingress directly to the pipe surface. The bottom holes were prepared to allow water that might enter the system to drain away. The two holes in each row were made 15 cm from the edge or the middle disc and 20 cm in between.

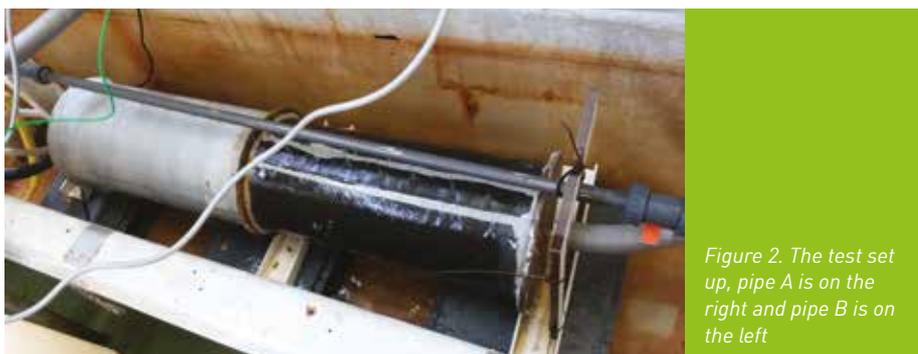
As with pipe A, two layers of HT/Armaflex Industrial insulation were applied to the pipe with Armaflex expansion spacers added to the 2nd layer (9 mm thick). The expansion spacers were introduced to mimic insulation systems installed with rigid covering in a real offshore facility. In this case a glass reinforced plastic (GRP) external weather barrier was used to cover the insulation. Holes were again drilled on the top of the insulation system and underneath but this time through the external weather barrier only. The insulation was left undamaged.

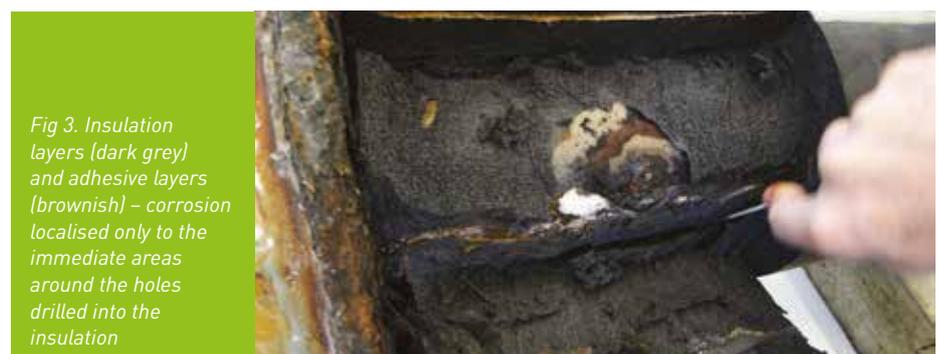
However, as the following images reveal, where corrosion occurred this was limited to the immediate areas around the holes drilled on the top of the pipe (at 2 and 10 o'clock).

It is important to note that it is the heating of the adhesive used by Armacell (from the 80°C of the water in the pipe) that has caused the general brown discoloration of the pipe surface – it is not the result of corrosion.

Whenever salt water comes into contact with steel pipe and oxygen is present, corrosion will occur. Corrosion would be accelerated in this test because the salt water was sprayed continuously, and the temperature of the pipe at 80°C created the optimal conditions for it to flourish. Given that salt water was allowed to directly come into contact with the surface of pipe A extensive corrosion could be expected at these damaged locations.

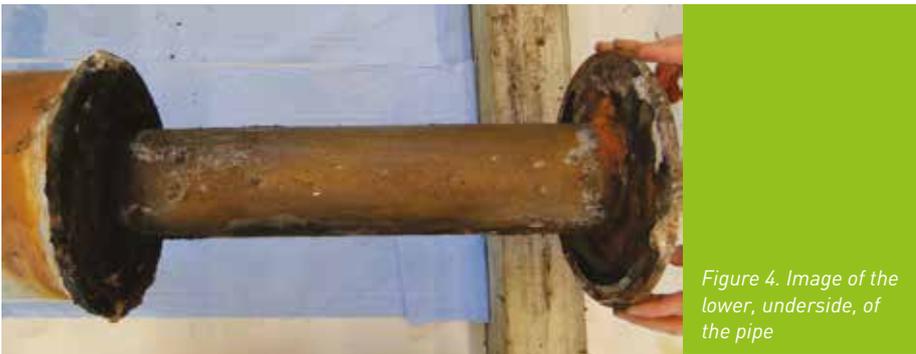
Notably, the underside of the pipe shows no sign of corrosion development (see Fig. 4). This means that no salt water reached the lower part of the pipe. The test institute concluded that this was due to the vapour barrier properties of the adhesive used by Armacell and of the closed-cell FEF material. The Institute says:

“No significant corrosion is observed in this area, which means that no salt water reached the lower part of the pipe through the holes and this can be attributable to the barrier properties of the good adhesive and the closed cell FEF insulation material.”

Figure 4. Image of the lower, underside, of the pipe

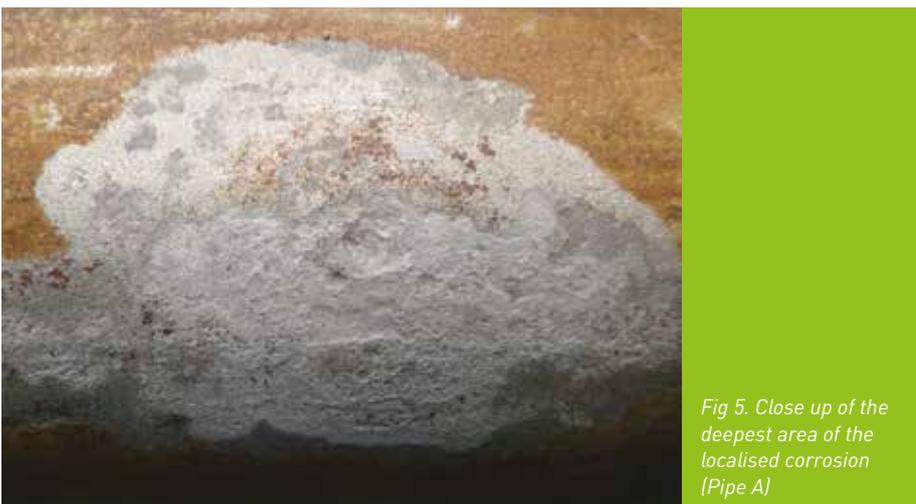
Given the extreme conditions of the test, it was inevitable that some localised corrosion would take place. A key part of the investigation was to look for the spread of corrosion outside of the damaged areas. The test demonstrated that corrosion was contained to the damage area and did not spread to the underside of the pipe, with limited lateral spread.

Fig 5. Close up of the deepest area of the localised corrosion (Pipe A)

The lack of corrosion spread was put down to the barrier properties of the closed cell FEF insulation material. **This performance was surpassed by pipe B.**

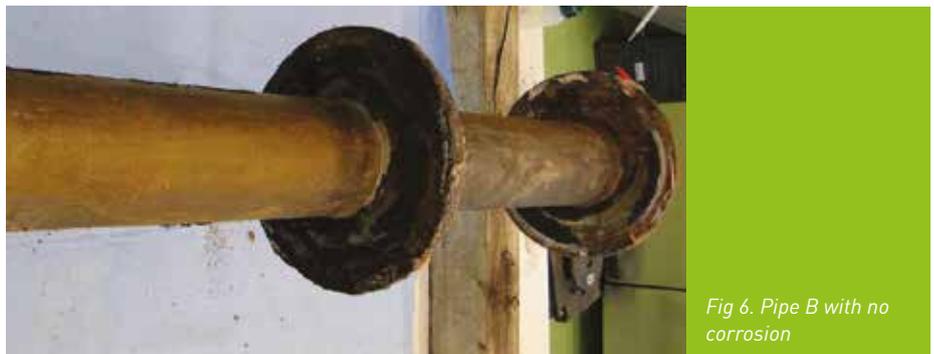
With pipe B, the drilled 5mm holes only penetrated the protective cladding. During the removal of the insulation it was noted that the outer layer of insulation was damp to touch. However, the inner layer remained completely dry. In its report the institute said: *“The outer layer of the insulation materials is wet but the inner insulation is still dry which is attributable to the barrier adhesive layer between the two insulation layers. No corrosion has been observed on the steel surface.”*⁵

The test laboratory noted that the 5mm hole on the underneath side of the weather barrier (protective cladding) had become blocked and water had pooled between this barrier and the insulation. However, both here, and across the whole pipe, the institute reports that: *“No corrosion has been observed on the steel surface.”*

In the case of pipe B, no corrosion was found at all. Water reached inside the weather barrier (protective cladding) but as Armaflex insulation acts as a barrier to water penetration, this prevented water from reaching the surface of the pipe.

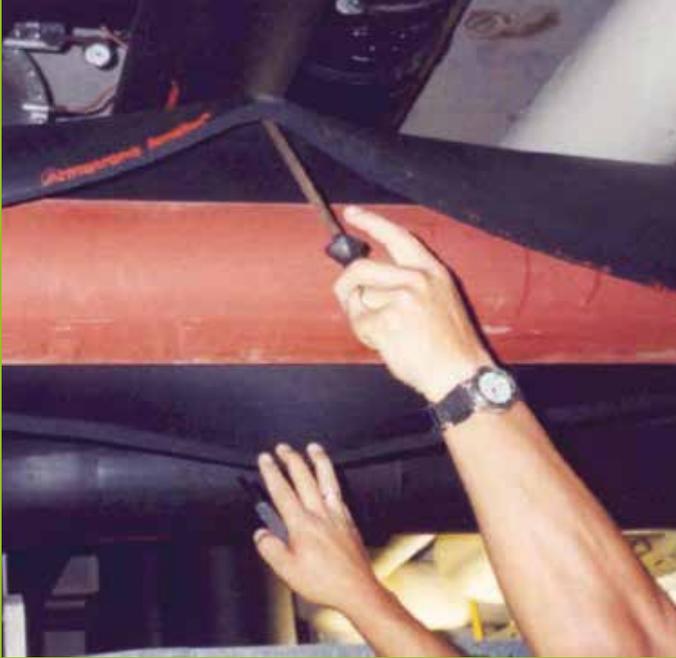
Fig 7: This cold water pipeline has been protected by Armaflex for 20 years - the picture shows maintenance inspection of the original system.
