CORROSION UNDER INSULATION (CUI)

Discover more about resistance to water vapor ingress in a high humidity environment.

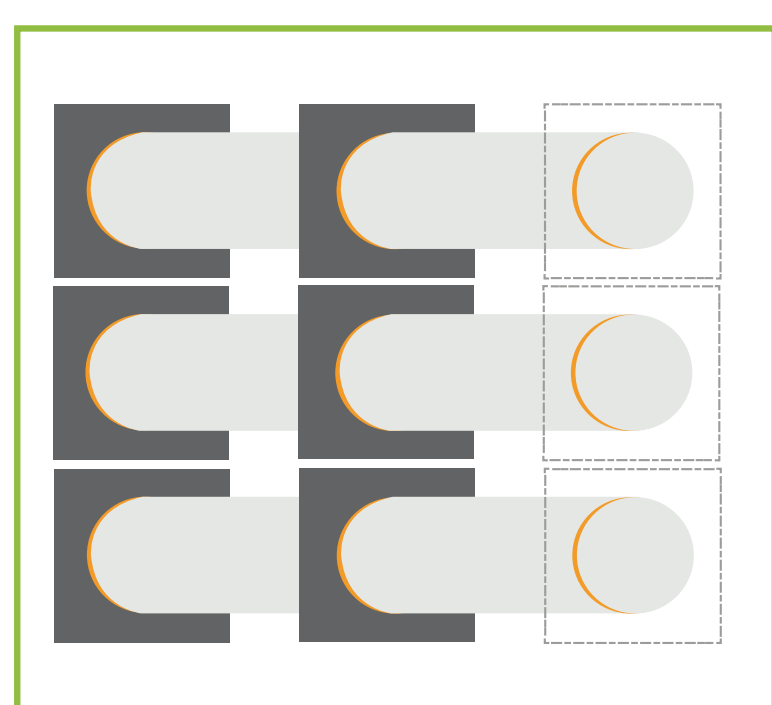
3 pipes of 2 sections each, with insulation assembled

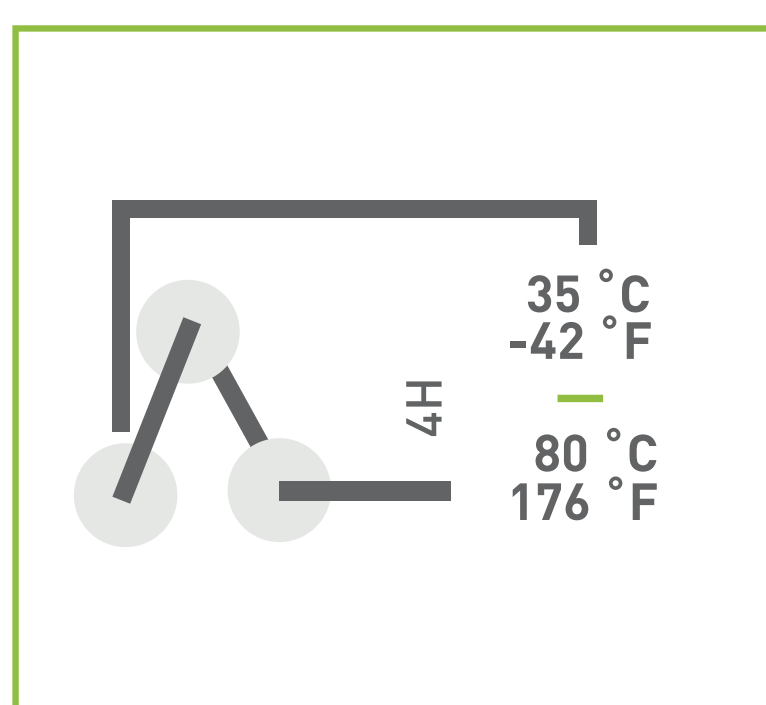
Pipes were installed in series with an air circulator

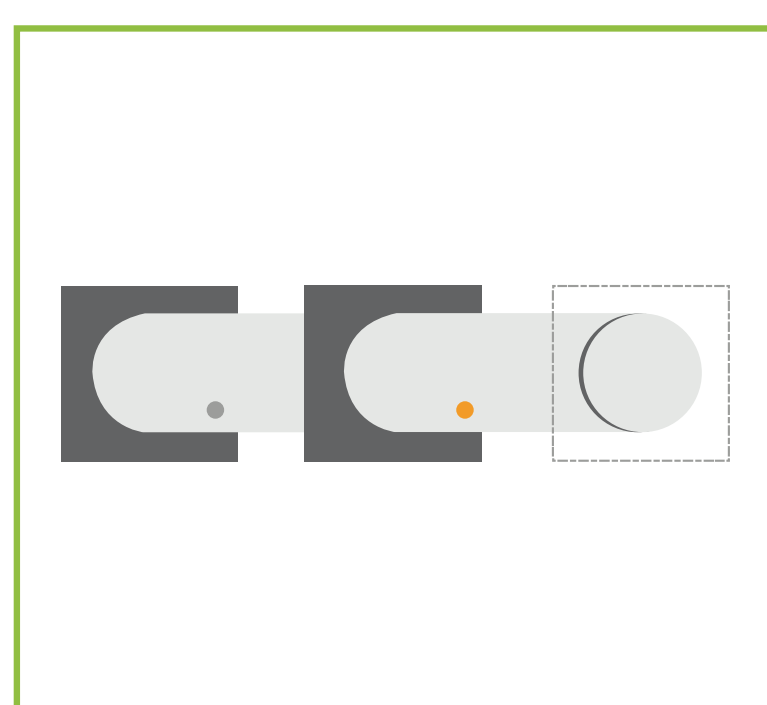
5 mm holes were punched into the insulation, simulating failure mode

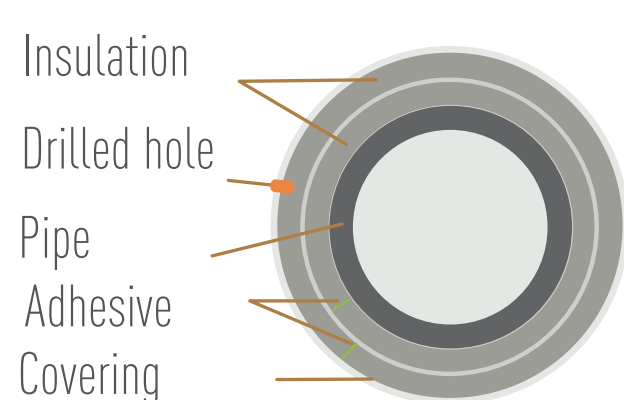
SAMPLE A ArmaFlex®

Adhesive between seams, overlaps and Arma-Chek® R covering

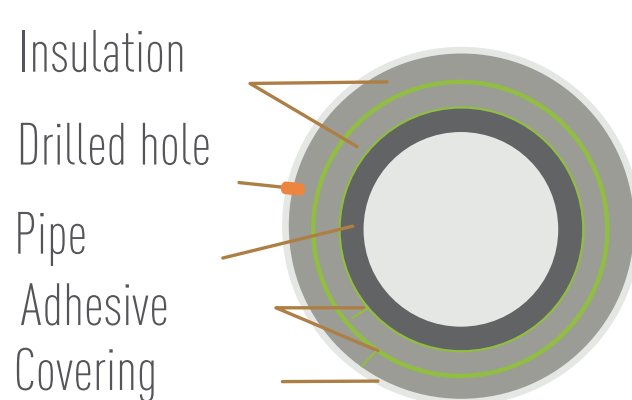
SAMPLE B ArmaFlex® with all-over-adhesion

All-over adhesion between layers and at pipe surface. Arma-Chek® R covering

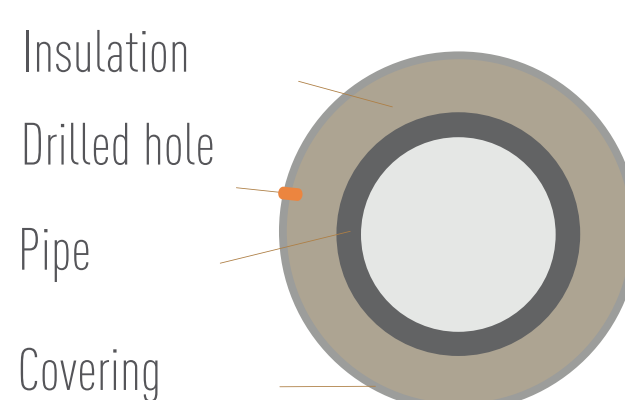
SAMPLES C, D, E Glass Fibre, Polyurethane, Stone Wool

Aluminium sleeve and tape

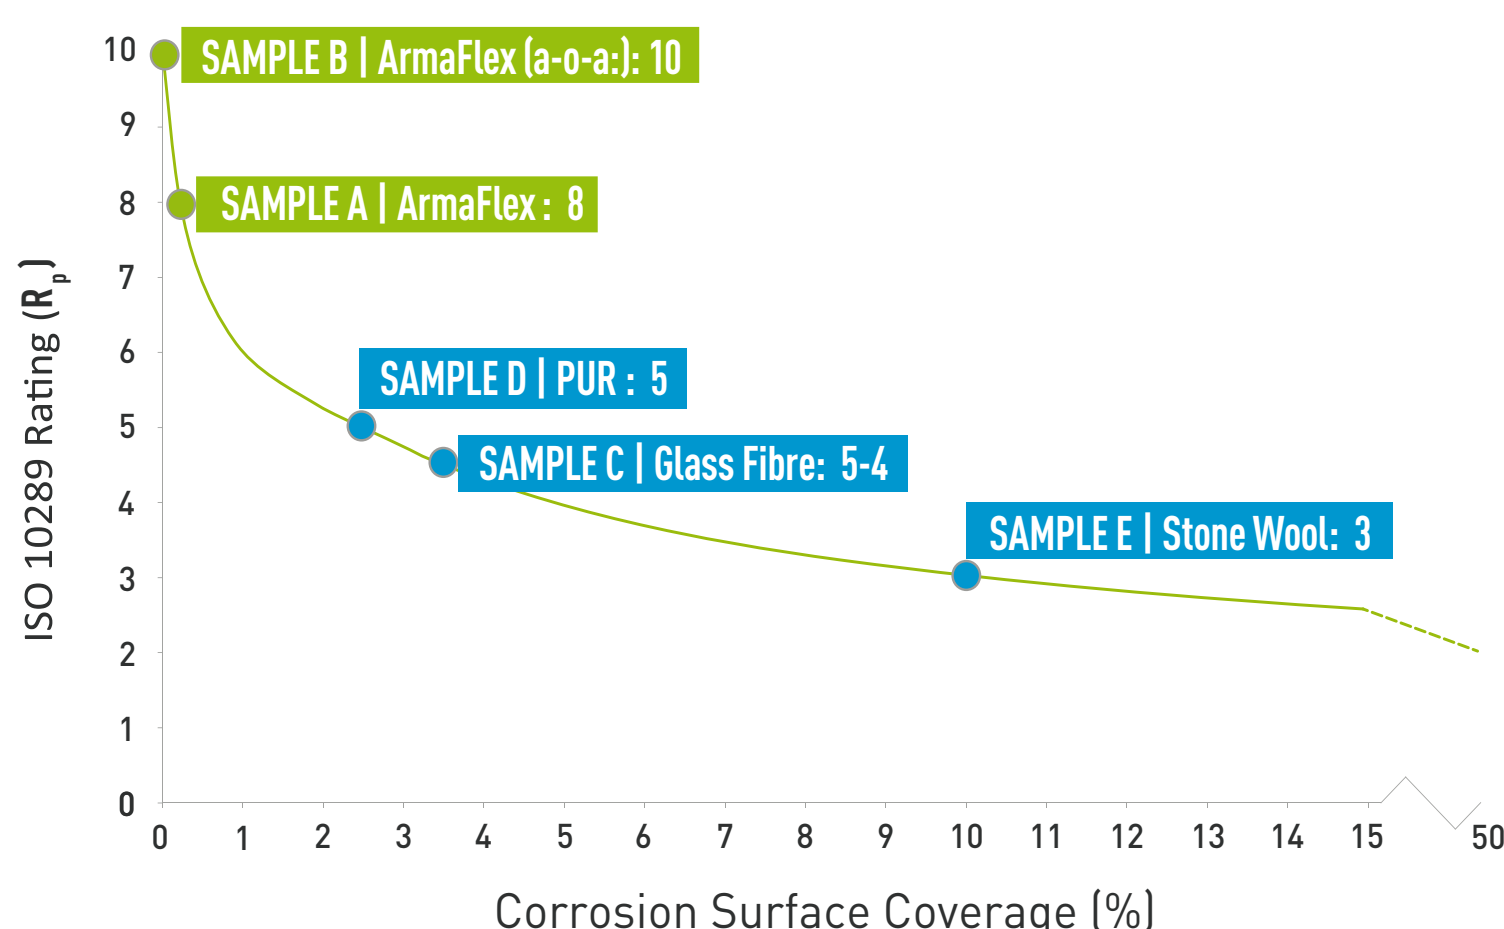
After 65 days, corrosion was measured and rated according to ISO 10289.

A value of R_p10 is the best rating, with 0% corrosion on the surface area.

InnCoa says, "Sample B, with the ArmaFlex System, is very tolerant against small defects and shows superior properties in protection against corrosion under insulation"
